Chapter 17

Planning and Constructing the Reservoir

This chapter is primarily based, with full permission, on the personal recollections of John Winder, and The Empingham Reservoir Project (Rutland Water) by A J H Winder MA FICE (formerly Chief Resident Engineer, Empingham Reservoir Project), R G Cole FICE (formerly Project Manager, Empingham Reservoir Project), and G E Bonnyer BSc FICE (Director of Operations, Anglian Water) which was presented to the Institution of Civil Engineers on 14th May 1985 and published in the Proceedings of the Institution of Civil Engineers, Volume 78, April 1985.

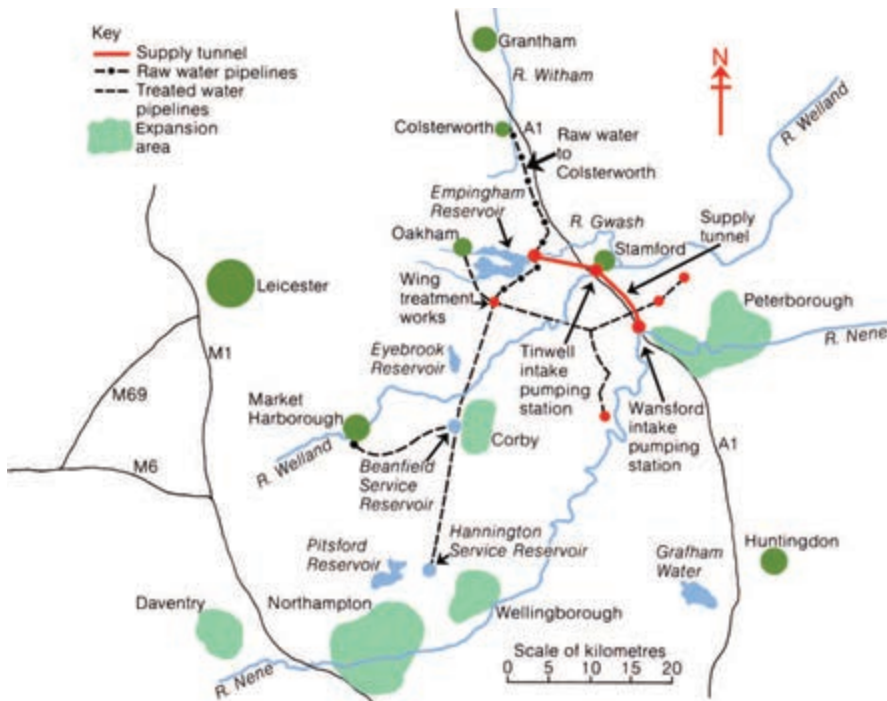
The Empingham Pumped Storage Project (after the Institution of Civil Engineers)

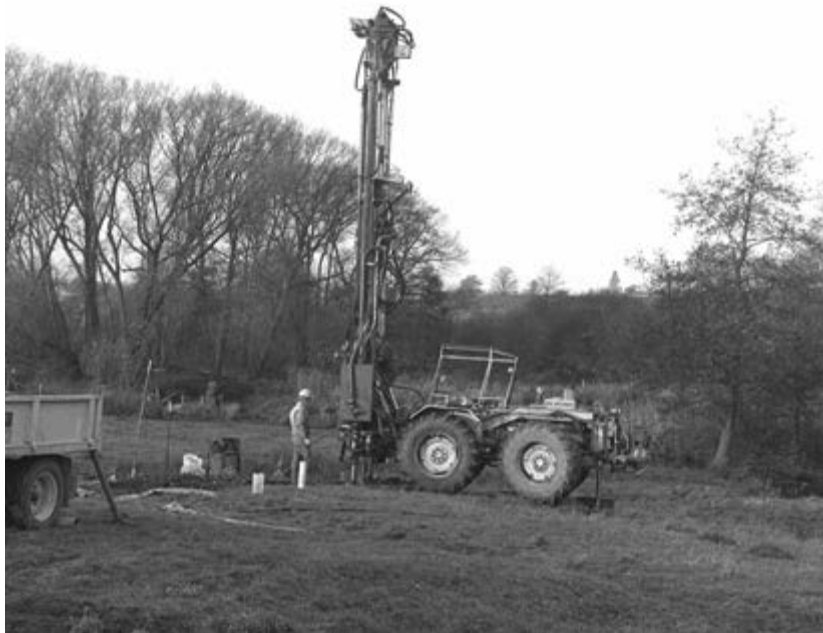
Below: The geological section at the dam site, looking upstream. The Marlstone Rock Bed is too deep to be affected by the valley bulge at this point, but the Upper Lias Clay is severely disturbed (after the Institution of Civil Engineers)

It was established at an early stage that, although the valley bulge penetrated 20m below the valley floor, the Marlstone Rock Bed at the dam site was not affected. This was an important discovery as, in this area, it is a confined aquifer containing water under pressure. If a rupture was exposed it would behave as an artesian well and flood the area very quickly. In order to reduce this pressure it was necessary to install relief wells on the downstream side of the dam to control the uplift pressure.

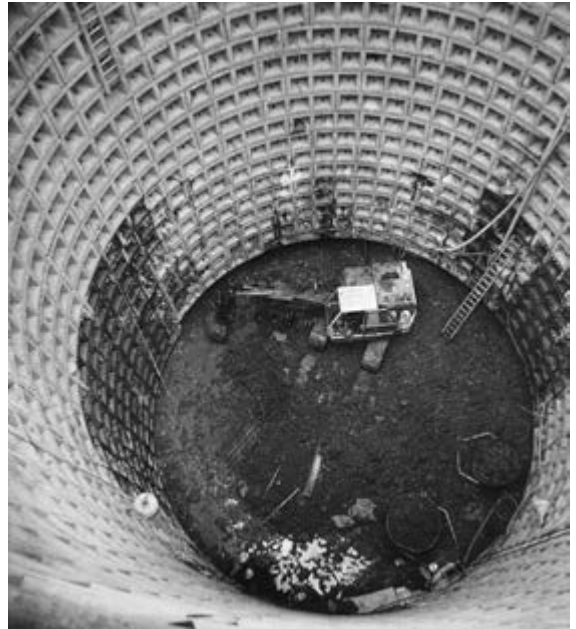
Above: Excavating the reservoir outlet shaft. It is 10.7m in diameter and over 30m deep (Brian and Elizabeth Nicholls Photography)

The outlet shaft, which is 10.7m internal diameter, was sunk first, followed by the two tunnel drives, all three being lined with concrete segments. The upstream and downstream tunnels are 3.7m and 4.4m internal diameter respectively. The upstream tunnel was lined with concrete infill panels and sprayed with an epoxy paint to provide protection against anaerobic water lying for long periods in this section of the tunnel.

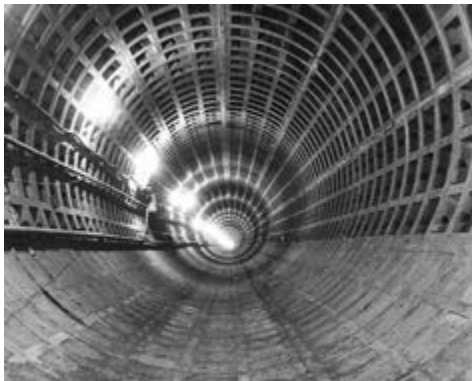
Above: The downstream diversion tunnel before the dividing platform was installed. It now carries the overflow water and other services
(Brian and Elizabeth Nicholls Photography)

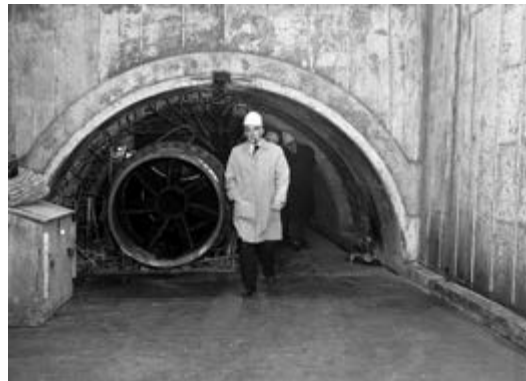
Left: The entrance to the top half of the downstream diversion tunnel
(Brian and Elizabeth Nicholls Photography)

The downstream tunnel, which was completed later under the main contract, is divided by a platform. In the top half, a 1.2m diameter steel pipe delivers the raw reservoir water to the outlet pumping station from where it is pumped to the water treatment works at Wing, or to Colsterworth, Lincolnshire. The remaining space is used as an access walkway, for power and control cables, and for other services. The bottom half of the tunnel carries the overflow from the reservoir and also any additional water necessary to maintain the minimum downstream flow of the River Gwash, known as the regulation water. It also carries water discharged through the scour pipe. The scour valve can be opened to let water out of the reservoir very quickly. For example, it can be used in an emergency if the dam is damaged or if it is necessary to lower the water level for any reason. The scour valve is also opened to flush sediment out of the reservoir when too much has collected behind the dam. The fast flowing water carries the sediment through the scour and downstream.

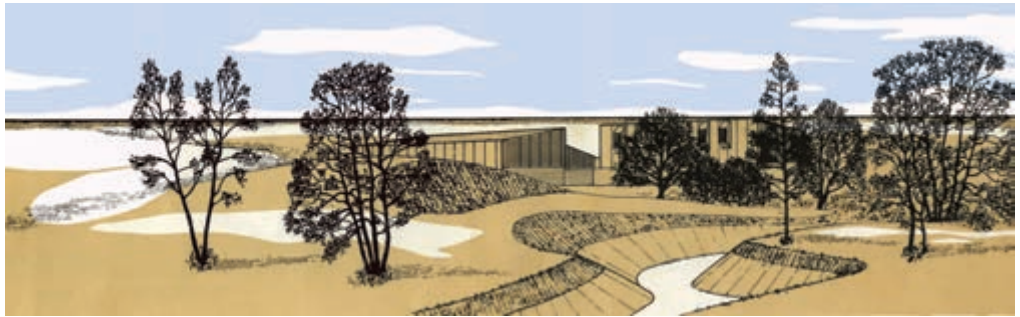
An early artist's impression of Empingham pumping station and the realigned River Gwash. The horizon is the crest of the dam (Anglian Water)

At the tunnel exit, there is a stilling basin and tailbay which incorporates a weir for measuring the river regulation water and the overflow water. Water is also discharged here from the Marlstone relief wells. A new river channel has also been constructed downstream from the tailbay to Church Bridge, Empingham, where the total water released is measured.

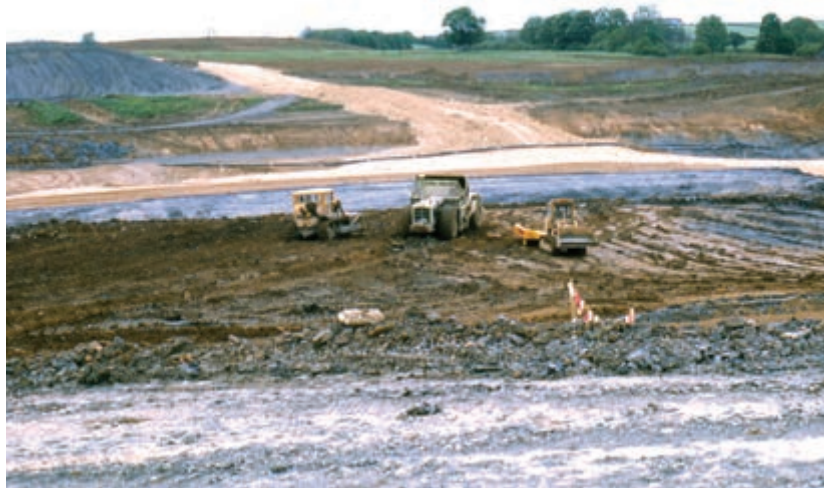
The trial bank can be seen upper left in this photograph (Brian and Elizabeth Nicholls Photography)

The trial embankment was built near the south side of the valley floor to avoid the main valley bulge. A trench was excavated into the valley side to ensure that it had a constant height over a length of about 70m, and calculations proved that the stress imposed on the foundation clay would be well in excess of that imposed by the final embankment.

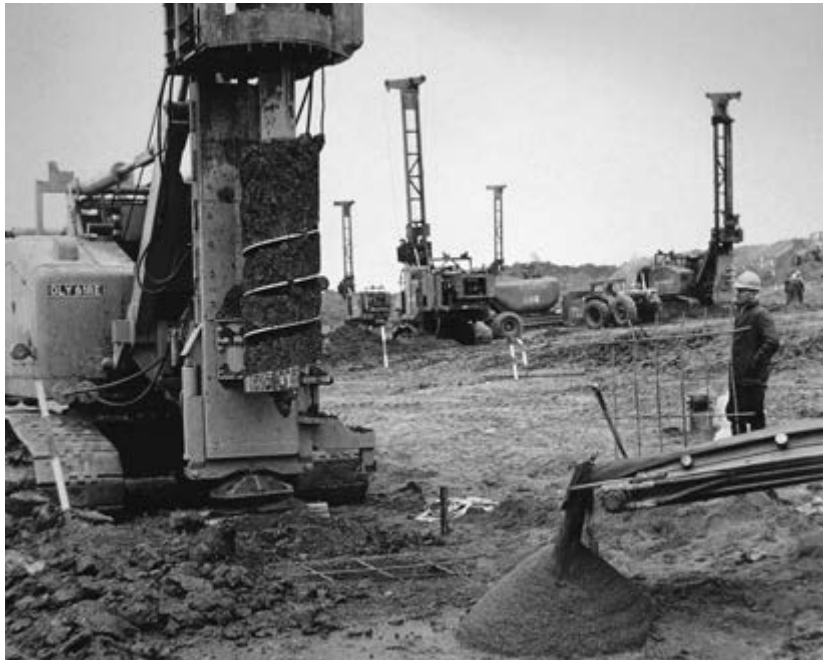
Installing sand drains in the foundation of the dam
(Brian and Elizabeth Nicholls Photography)

A feasibility study for the Empingham Dam indicated that, even with long slopes, sand drains would be required to ensure the stability of the clay foundation. The sand drains would collect water forced out of the pores of the clay by the weight of the dam above and drain via the drainage blankets within the dam structure.

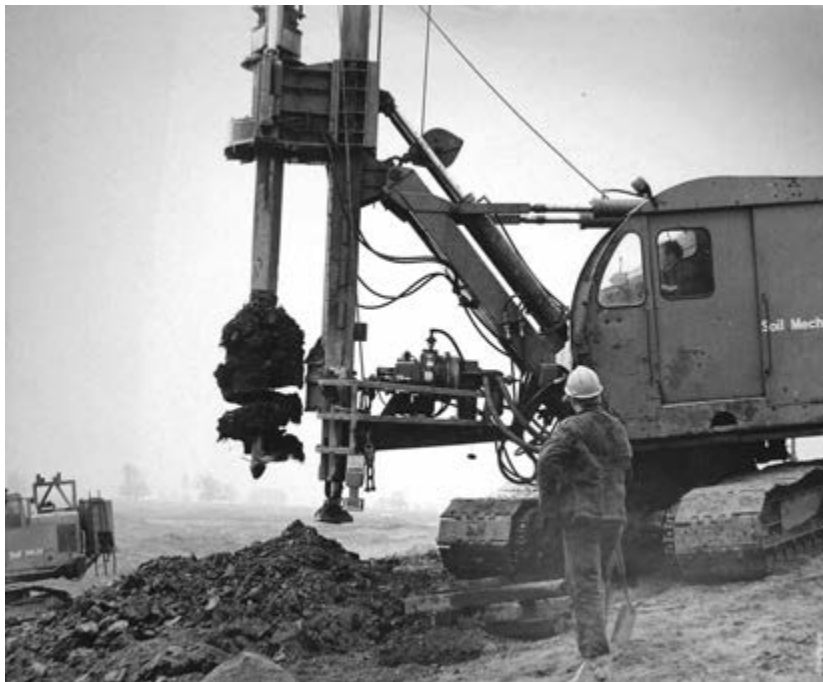
A crawler crane-mounted auger drilling a sand drain
(Brian and Elizabeth Nicholls Photography)

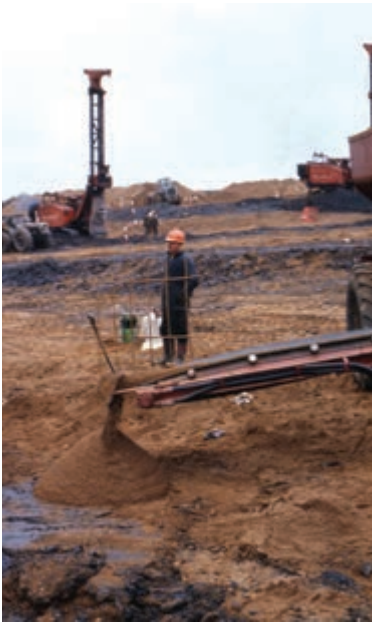
*Above: Filling a sand drain
(Brian and Elizabeth Nicholls Photography)*

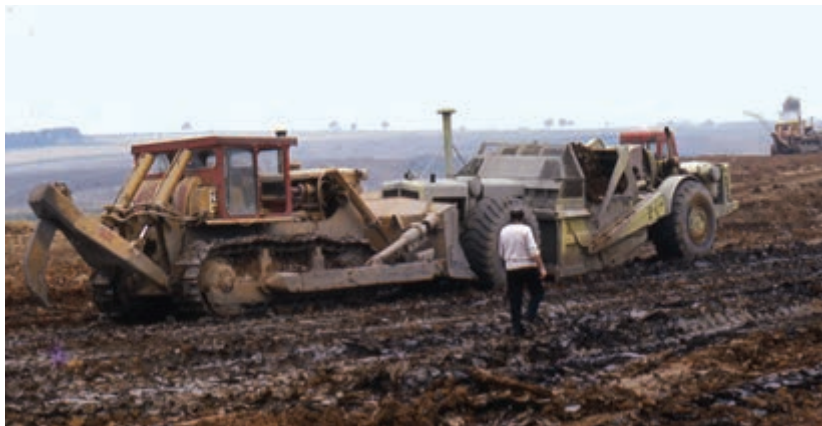
*Left: A heavily loaded Terex motor scraper gets a push from a bulldozer
(Brian and Elizabeth Nicholls Photography)*

*Right: Seven of the 12 twin-engined Terex motor scrapers ready for work. View looking from the dam towards Empingham
(Brian and Elizabeth Nicholls Photography)*

Material for the main embankment (dam) was placed using 12 Terex TS24 16 cubic metre twin-engined motor scrapers, ideal for the terrain and short-haul distances between the borrow pits and the embankment site. Bulldozers were used as pushers for the motor scrapers when collecting clay in the borrow pits.

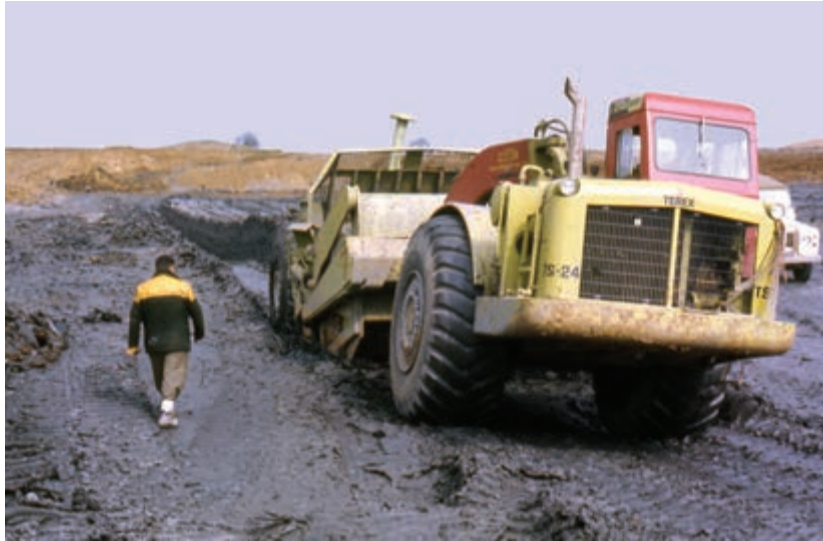
The south cut-off trench (Brian and Elizabeth Nicholls Photography)

Cut-off trenches, to prevent water leakage round the ends of the embankment, were excavated into the valley sides until the top of the Upper Lias clay was 1.7m above the reservoir top water level. These were then filled with clay to 2.2m above this level. Above this, the excavated surface material was replaced.

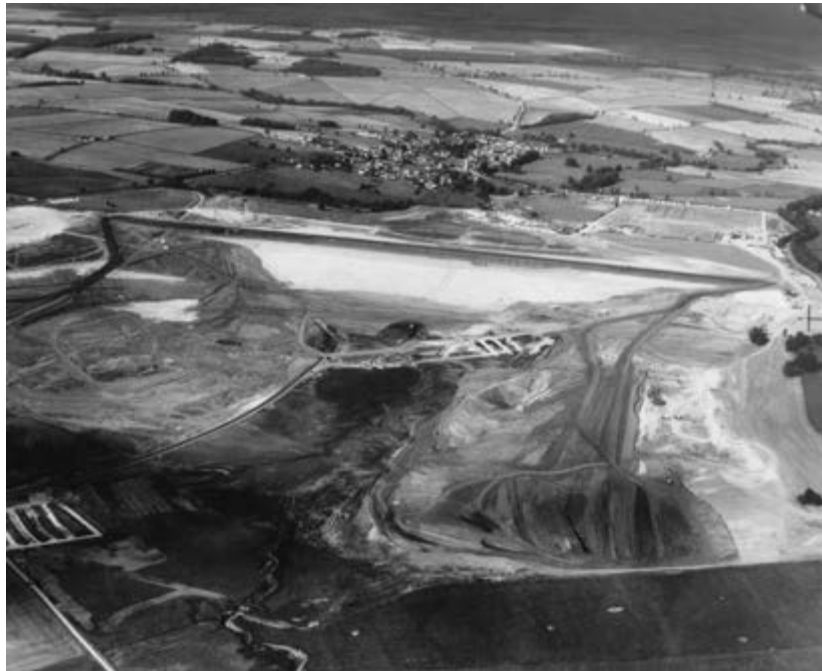
An aerial view of the borrow pits and the embankment, looking east towards Empingham (RCM)

The Upper Lias clay used for the embankment construction was extracted from borrow pits located below top water level upstream of the dam. They were excavated to full depth in sections, surface material being placed in worked-out areas. The drainage of the underlying Marlstone Rock Bed (*see later*) allowed the borrow pits to be deepened without risk of uplift through artesian pressure. However, a section brought upwards by valley bulging was unexpectedly exposed in the south borrow pit. It was subsequently blanketed with clay to prevent leakage from the reservoir.

Dam construction commenced with the placing of clay in the down-stream slope. At first, excavation was restricted to the south borrow pit to increase the supply of deeper and drier clay. Fill placing for the upstream slope was restricted in 1972 by the construction of the trial bank. In 1973 the surface materials from the north borrow pit were placed on this slope and thereafter both borrow pits were used.

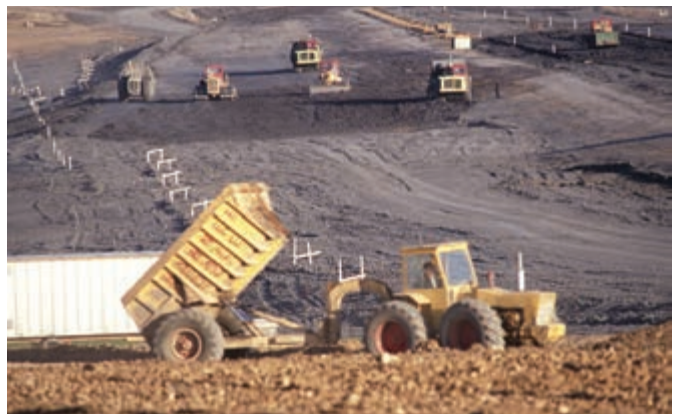
Spreading and compacting the clay at the south end of the embankment (Richard Adams)

As the construction progressed, it was found necessary to adjust the water content of the clay. A section of the embankment was marked out and the requisite number of TS24 scraper loads was placed to give an uncompacted layer thickness of about 200mm. This was graded with a bulldozer and the clay was broken up by several passes of a heavy tine harrowing unit. This brought up claystones from the fill which were removed by hand by a gang of six men – claystone is fully-hardened clay material which does not break down when wetted. The contractor then quickly measured the water content using a microwave oven. The amount of water to be added was assessed and then placed using water bowsers equipped with sprays. The clay was then rotavated. Further watering and rotavating was carried out as required and the layer finally compacted.

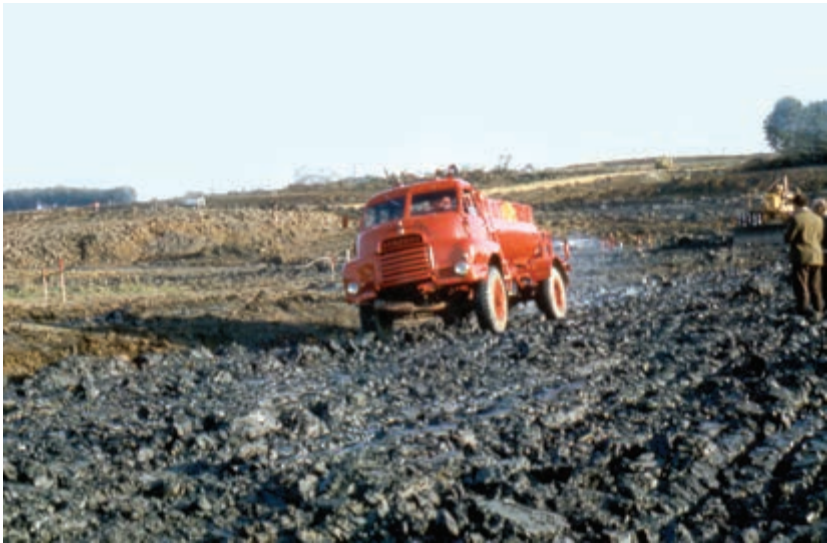
Watering the clay prior to harrowing and further compacting (Brian and Elizabeth Nicholls Photography)

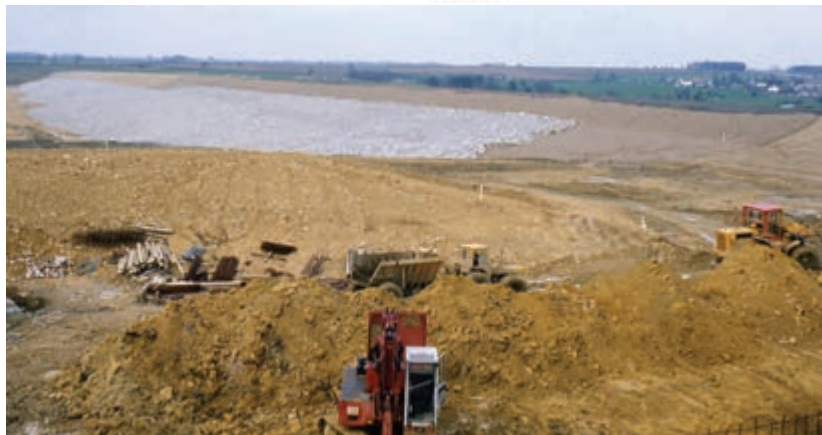
*Placing the
limestone
and ironstone
beaching on
the upstream
face of the
embankment
(Brian and
Elizabeth
Nicholls
Photography)*

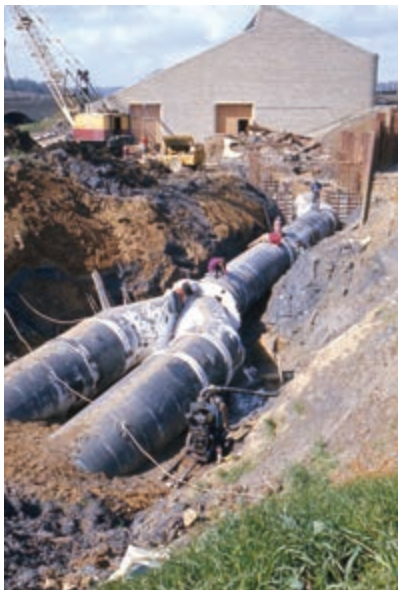
*Steel pipes
being installed
near Wansford
pumping station
(Brian and
Elizabeth
Nicholls
Photography)*

Because of faulting and valley bulging, the tunnels were replaced by pipelines across the Nene and Welland valleys. Twin 1.8m diameter pipelines were laid from Wansford pumping station to shaft 1 and also across the Welland Valley to link shafts 3 and 4.

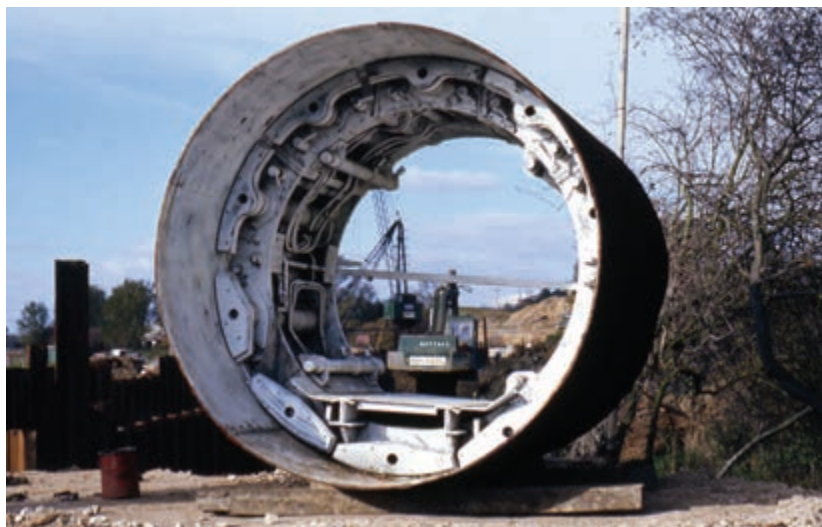
*The shield of one
of the tunnelling
machines
(Brian and
Elizabeth Nicholls
Photography)*

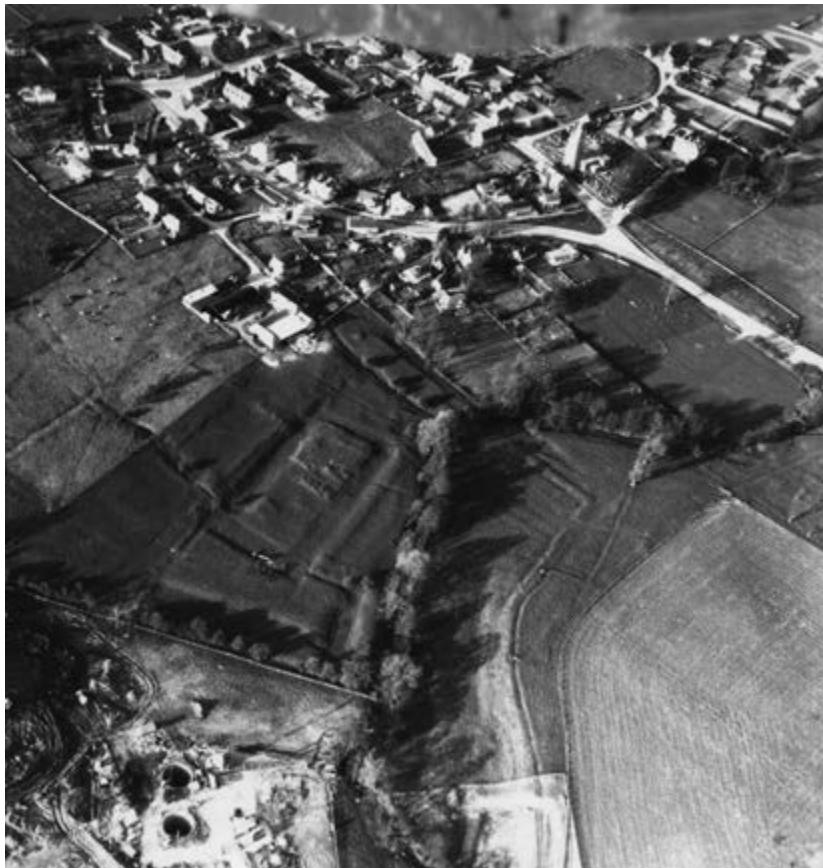
The twin shafts can be seen at the lower left of this picture, which also includes part of Empingham and its medieval manorial earthworks (Fred Adams)

When excavation restarted in the twin shafts and connecting tunnel, it was found from the attitude of the Pisolite Bed (a narrow band of coarse-grained limestone within and at the lower level of the Upper Lias clay) that the bottom of the excavation had penetrated the edge of the valley bulge. The steep bedding and disturbed condition of the material had allowed easy access for the water from the Marlstone Rock Bed into the base of the shaft.

The twin shafts were completed satisfactorily, and advantage was taken of the lowered water level to drive about 200m of bolted lining tunnel out from the connecting tunnel. This took the tunnel clear of the area of valley bulging, which would have caused problems as the main tunnel approached Empingham.

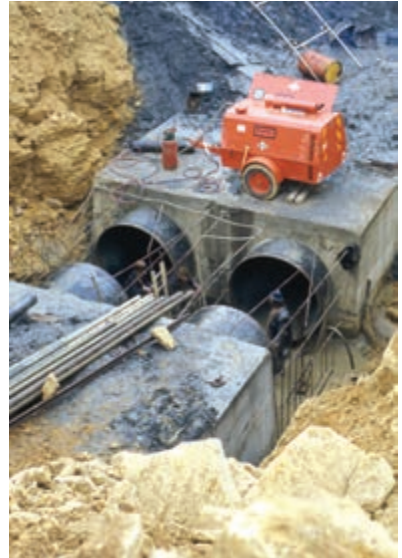
Above: Pipes were encased in concrete below the bed level of the River Welland (Brian and Elizabeth Nicholls Photography)

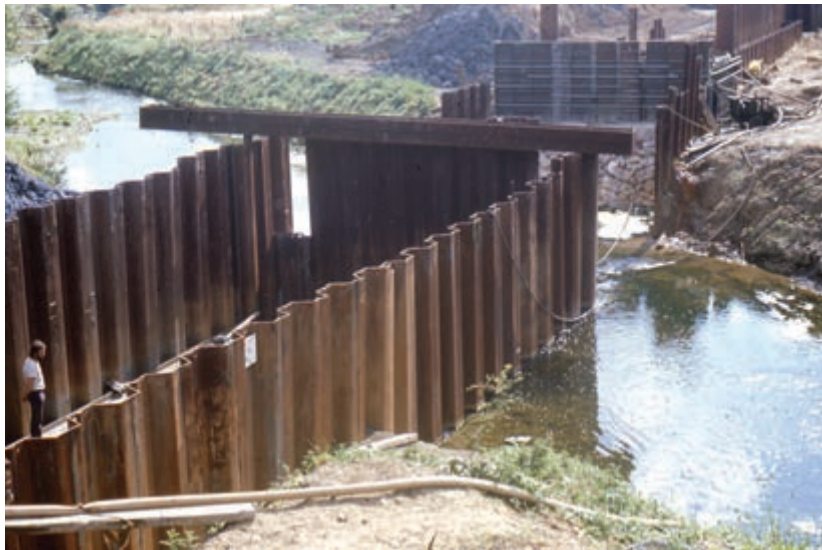
Right: Crossing the River Welland at Tinwell (Brian and Elizabeth Nicholls Photography)

There were two other problems to contend with in crossing the Welland Valley – the river itself, and the railway line between Leicester and Peterborough. In order to cross the River Welland it was first necessary to de-water the gravels near the river crossing point. The twin pipelines were then laid in a sheet-piled cofferdam taken half-way across the river channel. This allowed the normal flow in the river to continue while the pipes were encased in concrete below river bed level. The sheet piles were then withdrawn and the whole process was then repeated for the other half of the river.

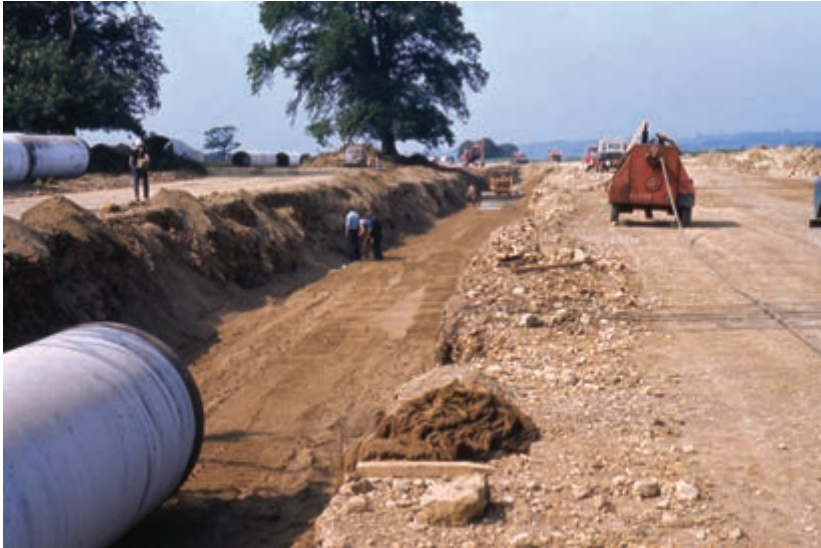
*Installing the
twin reservoir
inlet pipes near
Normanton*
(Brian and
Elizabeth
Nicholls
Photography)

Raw water from the rivers Nene and Welland starts the final part of its journey at the final lift pumping station located over the twin shafts (6A and 6B) near the downstream toe of the embankment at Empingham. From here twin reservoir inlet pipelines run along the southern shore of the reservoir for about 2.7km to the inlet jet control valves at Howells Inlet, near Normanton Church Museum. Four lines of pre-stressed concrete pipes carry the inlet water down into the reservoir from where it is discharged by four jets pointing up the south arm.

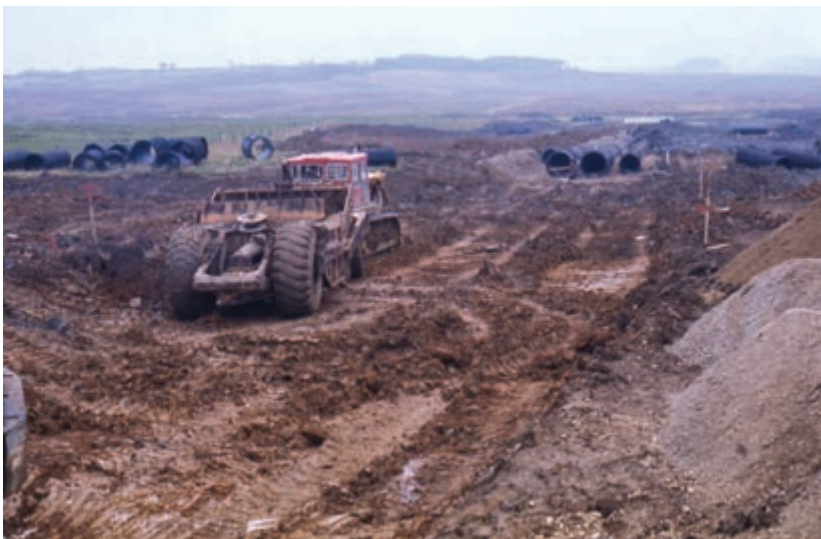
*The four pipes
to the inlet jets
being installed
across the
valley floor
near
Normanton*
(Brian and
Elizabeth
Nicholls
Photography)

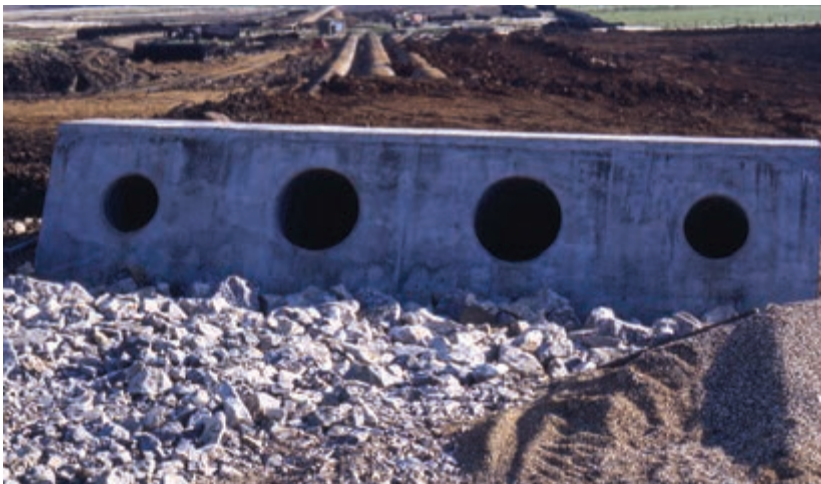
*The four inlet
jets pointing up
the south arm
of the reservoir*
(Brian and
Elizabeth
Nicholls
Photography)

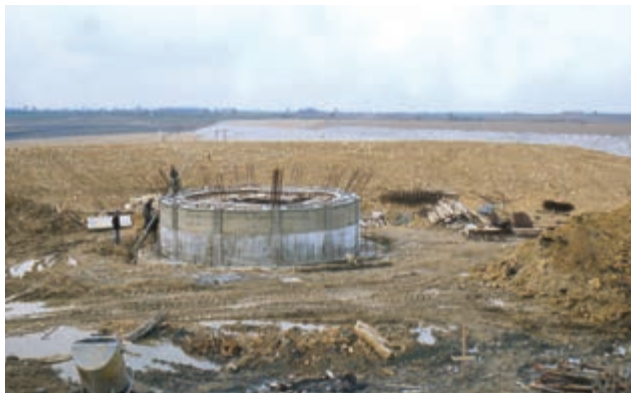
Right: Building the outlet shaft (Brian & Elizabeth Nicholls Photography)

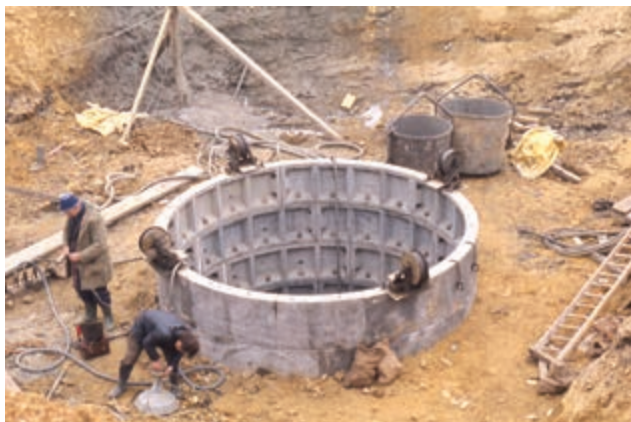
Right: Working on the overflow shaft (Brian & Elizabeth Nicholls Photography)

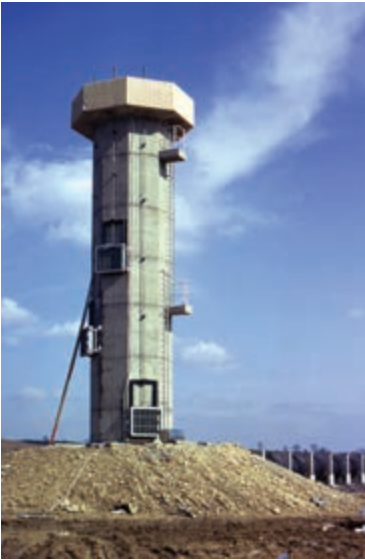
A secondary outlet tower was constructed in the north arm of the reservoir, with a 1.35m diameter pre-stressed concrete pipeline laid in the bed of the reservoir to the main outlet shaft.

Above: The secondary outlet tower in the north arm of the reservoir near Barnsdale
(Andrew Burns)

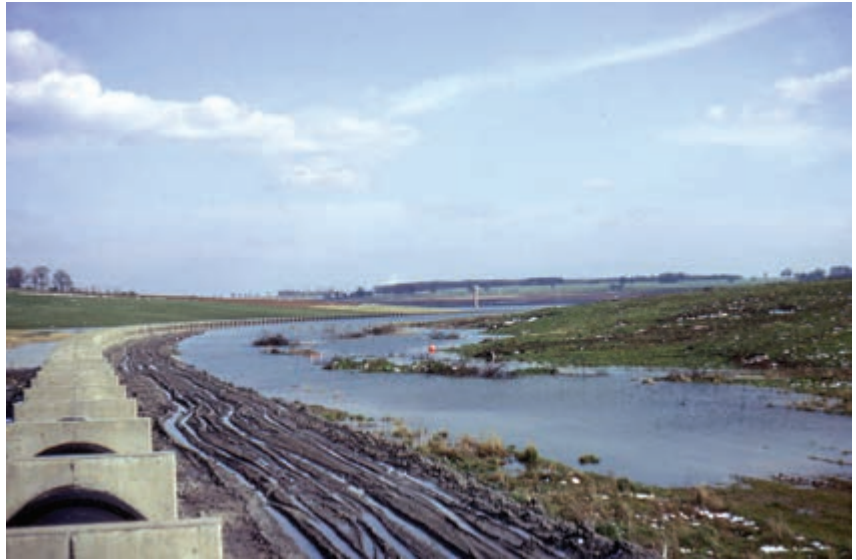
Above Right: Looking along the secondary outlet pipe towards the limnological tower
(Andrew Burns)

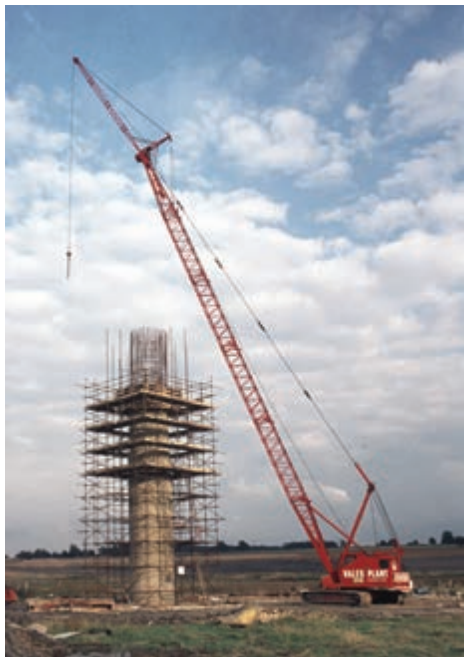
*Building the
limnological
tower near Bull
Bridge
(Richard
Adams)*

Problems of algal blooms and of reservoir thermal stratification leading to the bottom water becoming starved of oxygen (anaerobic) were anticipated at the design stage of the reservoir. In order to overcome the algal problem, it was proposed that the north arm of the reservoir should be operated as a second reservoir, and a model of the reservoir was constructed by the River Authority to prove the feasibility of this proposal. Various combinations of inlet and outlet arrangements were tried using tracer dye to identify and record the different circulation patterns produced. It was found that the most effective scheme was to discharge all the water into the mouth of the south arm through an inlet jet system in the bottom of the reservoir, the four jets pointing up the arm of the reservoir. The normal water outlet is through the main outlet shaft, drawing water from the main body of the reservoir. In this way, the water that enters the north arm of the reservoir will have been subjected to a longer period of retention, and will be of different biological and chemical characteristics from that in the main body. When algal growth is experienced in the main body, it is unlikely to occur at the same time in the north arm and vice versa. To take advantage of this, a secondary outlet shaft and pipeline in the north arm allows water to be drawn from there during periods of bad algal growth in the main body, except at low water levels in the reservoir. In the unlikely case that algal growth affects the whole reservoir, river water can be pumped directly to the treatment works.
